March 2023

Cyclone Gabrielle Woody Debris Species Composition Assessment

Submitted to:
Hawke's Bay Regional Council

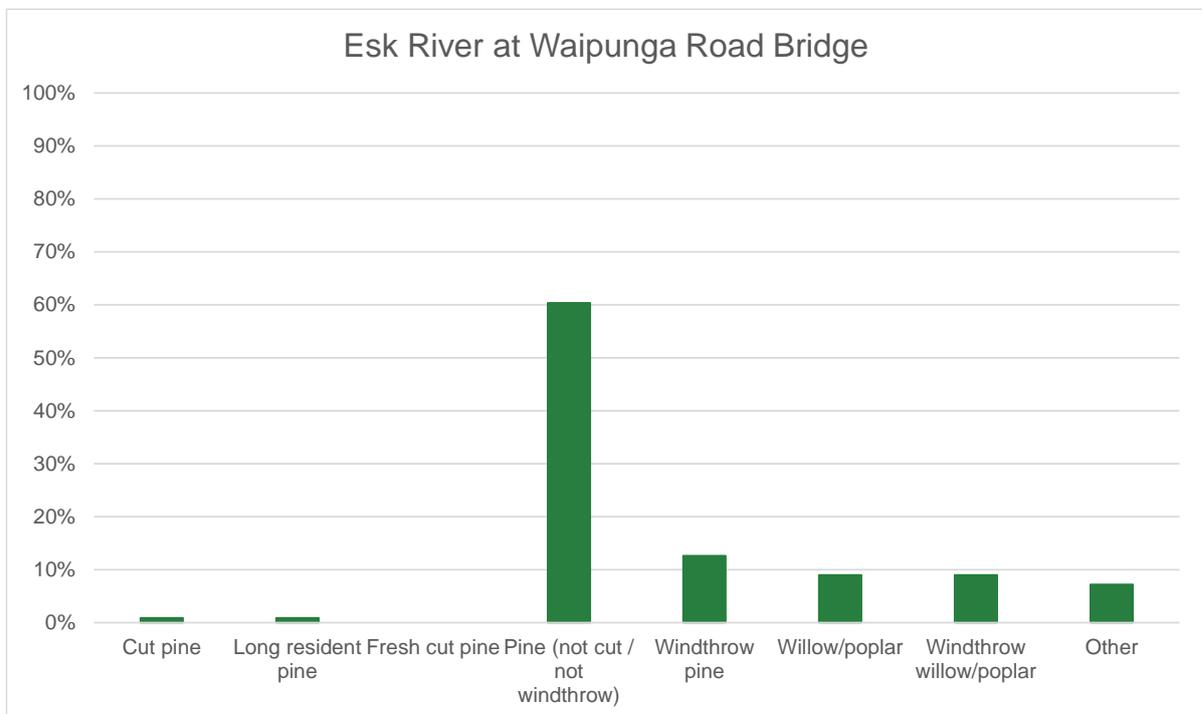
Figure 2: Within species breakdown of woody debris by piece type at Site 1.

The proportion of cut pine (whose source would be historic or current forestry harvesting operations) was 1% (Figure 2). The proportion of long resident pine debris was similarly low (1%). Interestingly the proportion of both windthrow pine (13%) and windthrow willow/poplar (9%) were similar.

The overwhelming majority of woody debris was however pine 'pieces' (60%) which constituted pieces of woody debris not evidencing cut (or other) marks indicating that they had been harvested.

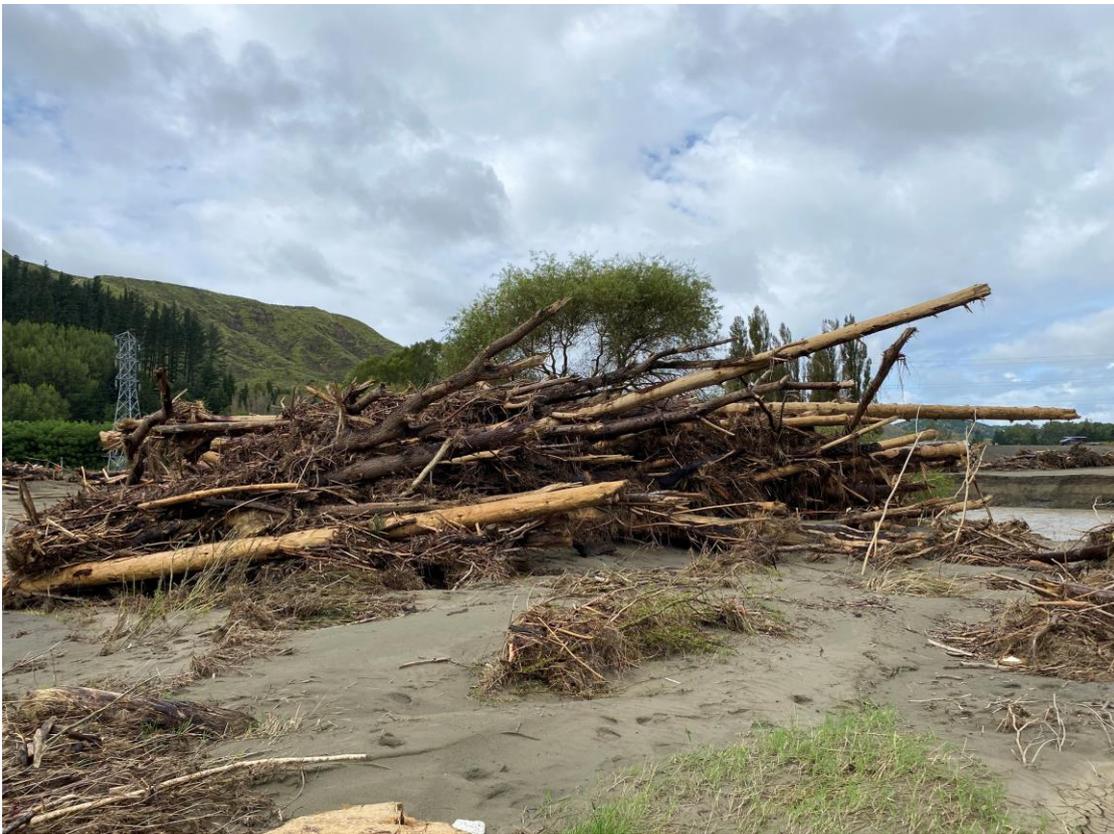
Figure 4: Typical woody debris accumulation assessed at Site 1.

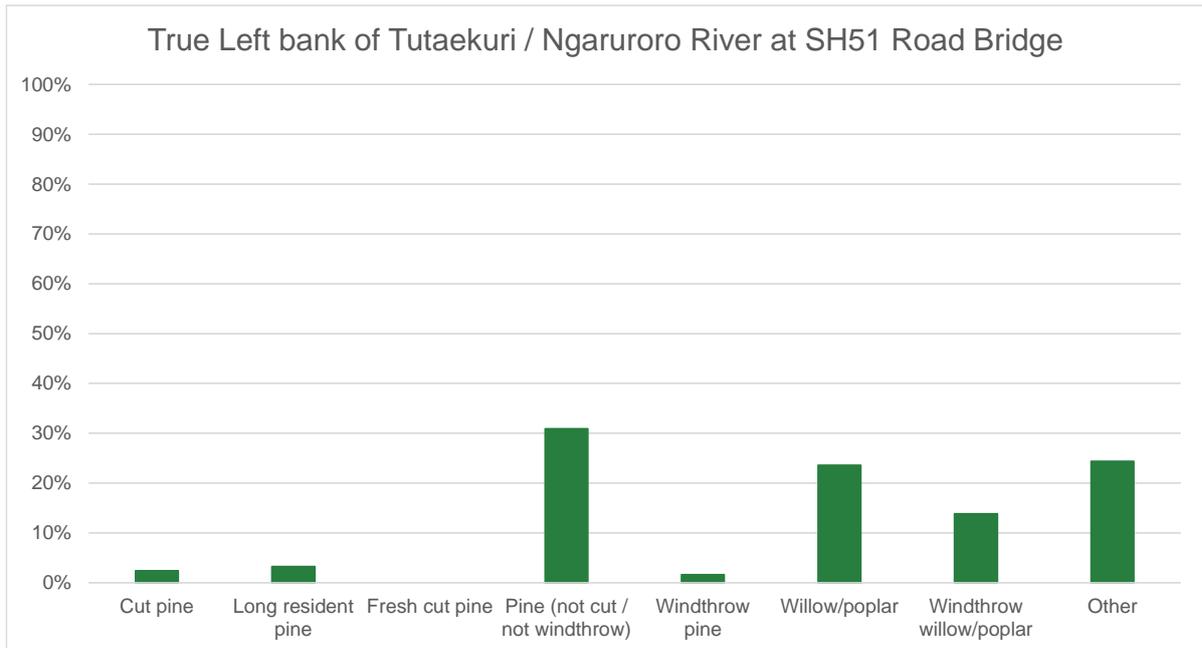
Figure 5: Within species breakdown of woody debris by piece type at Site 2.

The proportion of cut pine (whose source would be historic or current forestry harvesting operations) was 2% (Figure 5). The proportion of long resident pine debris was similarly low (3%). Interestingly the proportion of both windthrow pine (2%) and windthrow willow/poplar (14%) were quite different, perhaps reflecting the scale of river protection plantings within the catchment².

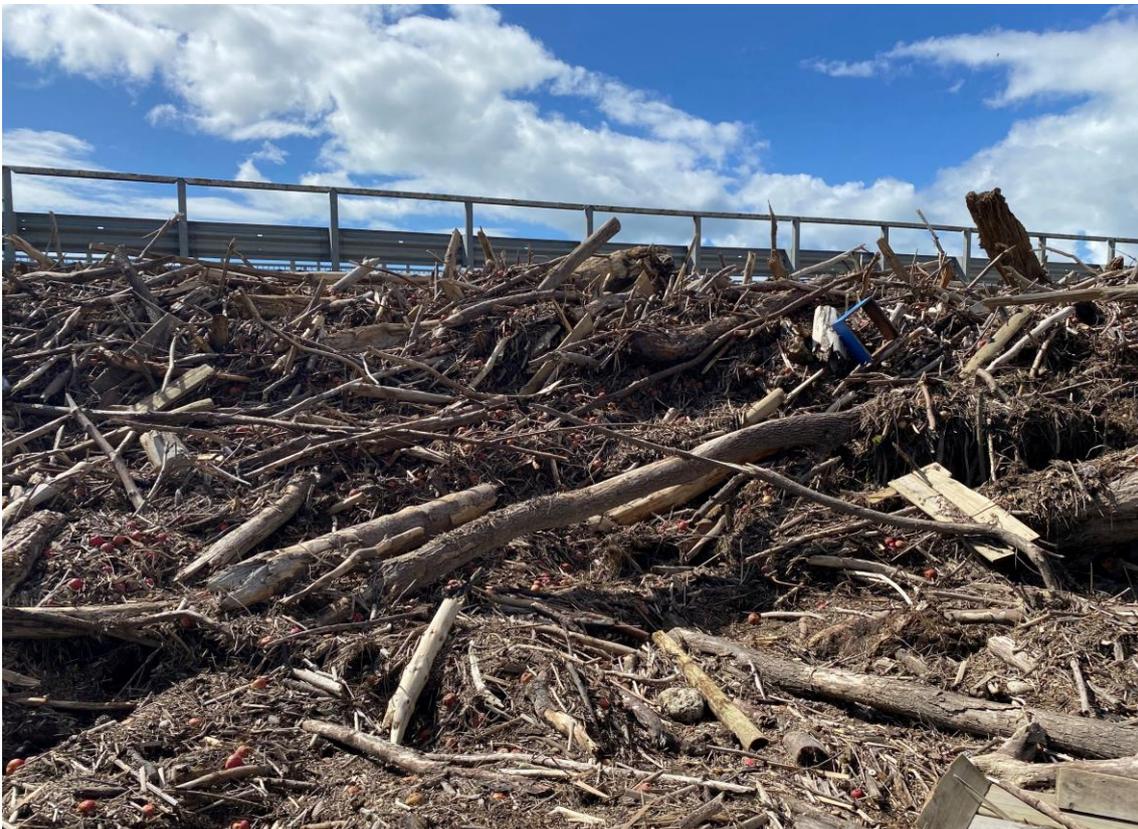
Figure 7: Typical woody debris accumulation assessed at Site 2.

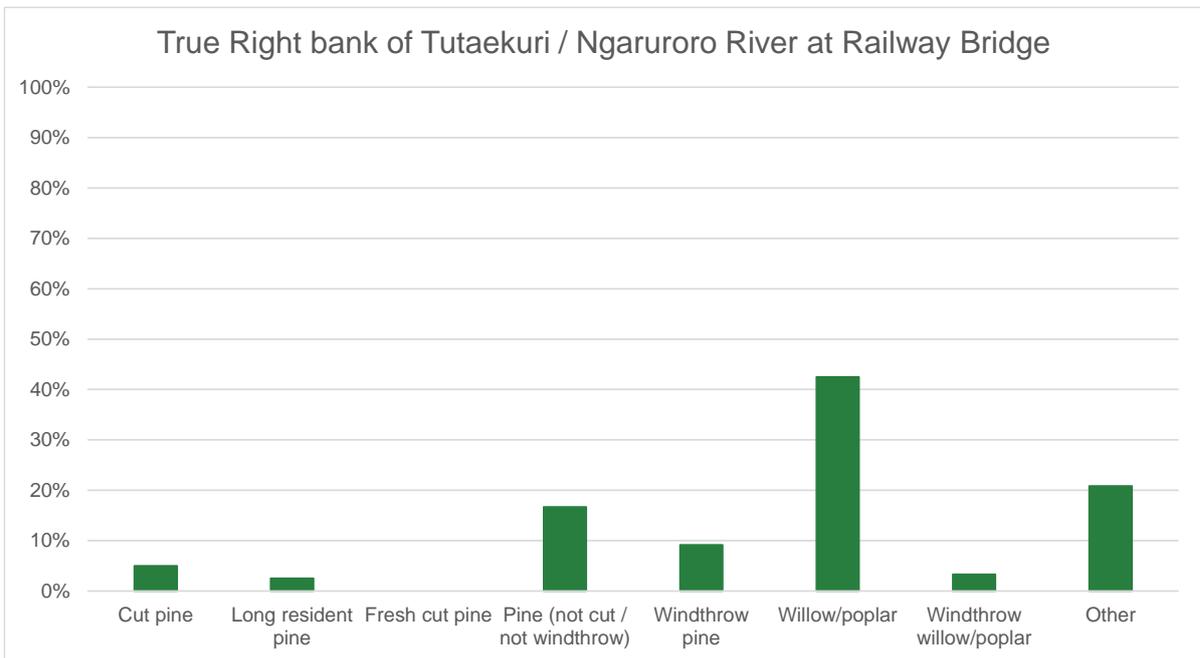
Figure 8: Within species breakdown of woody debris by piece type at Site 3.

The proportion of cut pine (whose source would be historic or current forestry harvesting operations) was 5% (Figure 8). The proportion of long resident pine debris was 3%.

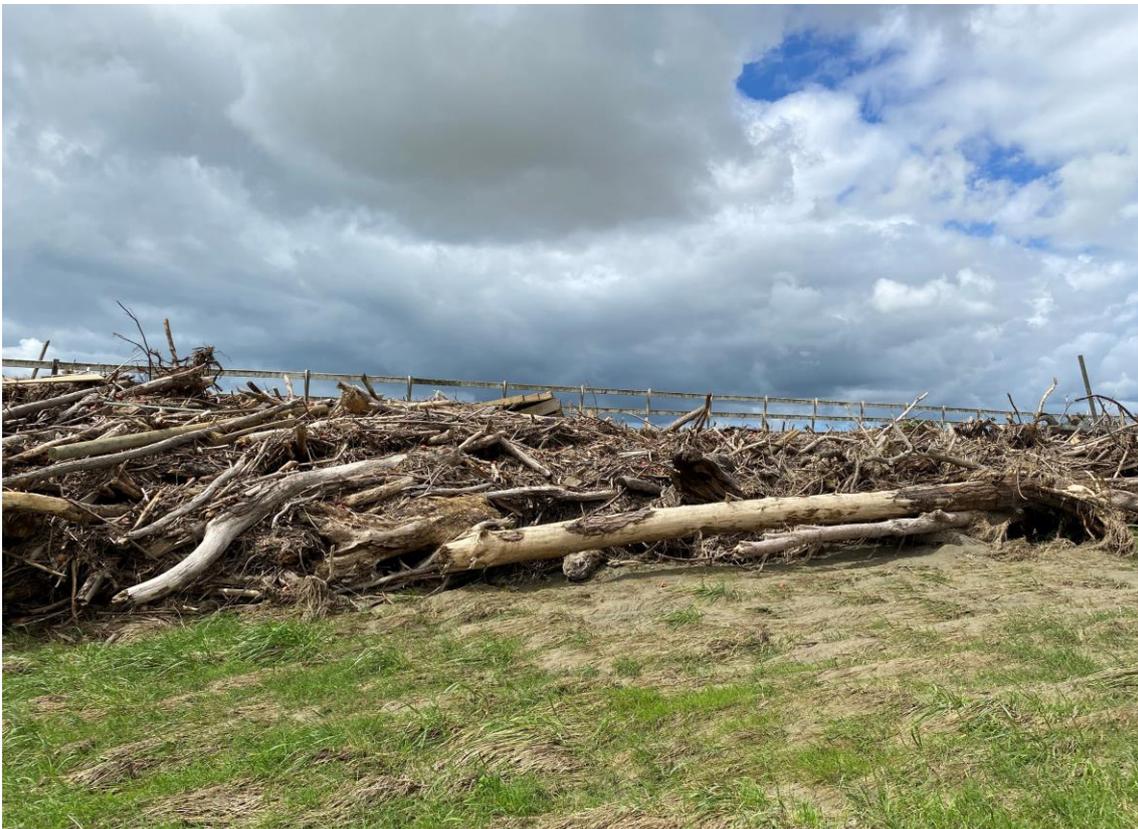
Figure 10: Typical woody debris accumulation assessed at Site 3.

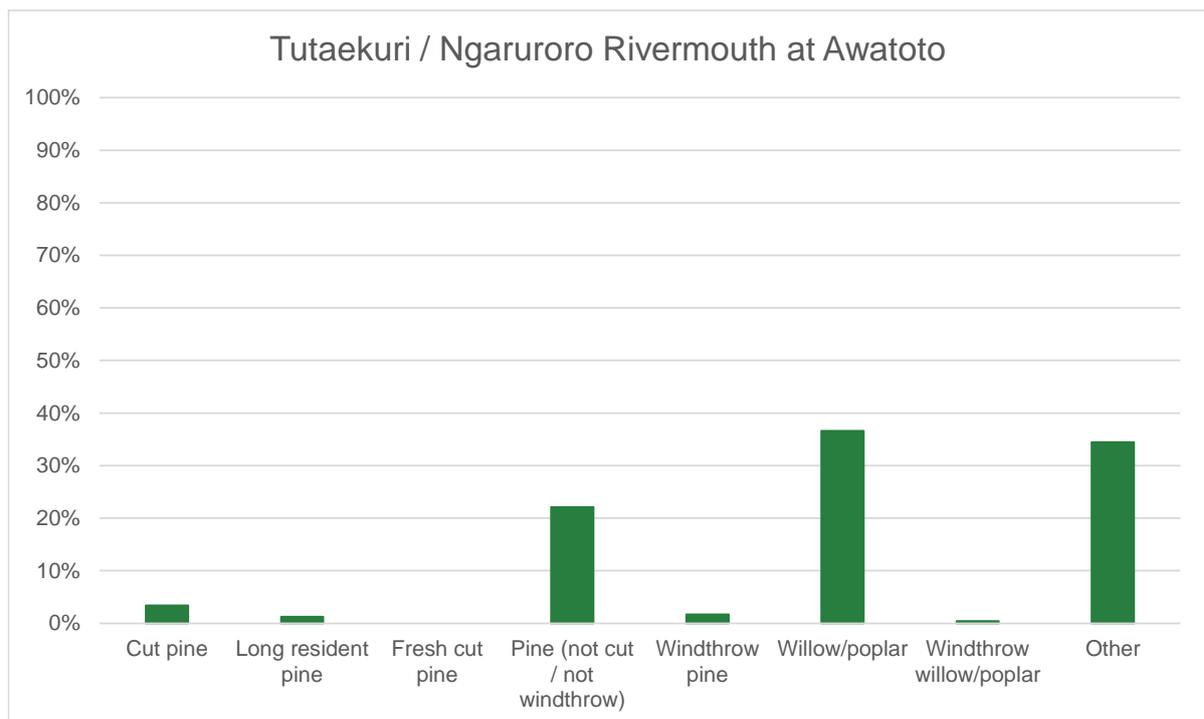
Figure 11: Within species breakdown of woody debris by piece type at Site 4.

The proportion of cut pine (whose source would be historic or current forestry harvesting operations) was 3% (Figure 11). The proportion of long resident pine debris was similarly low (1%). The low proportions of both windthrow pine (2%) and windthrow willow/poplar (<1%) may reflect the fact that much of this material was held up at the road and rail bridges (Site 2 and Site 3) where windthrow proportions were higher at 16% and 12% respectively.

The majority of woody debris assessed was willow/poplar (37% - not including the <1% categorised as windthrow), with the next highest categories being other species (34%) followed by pine 'pieces' (22%).

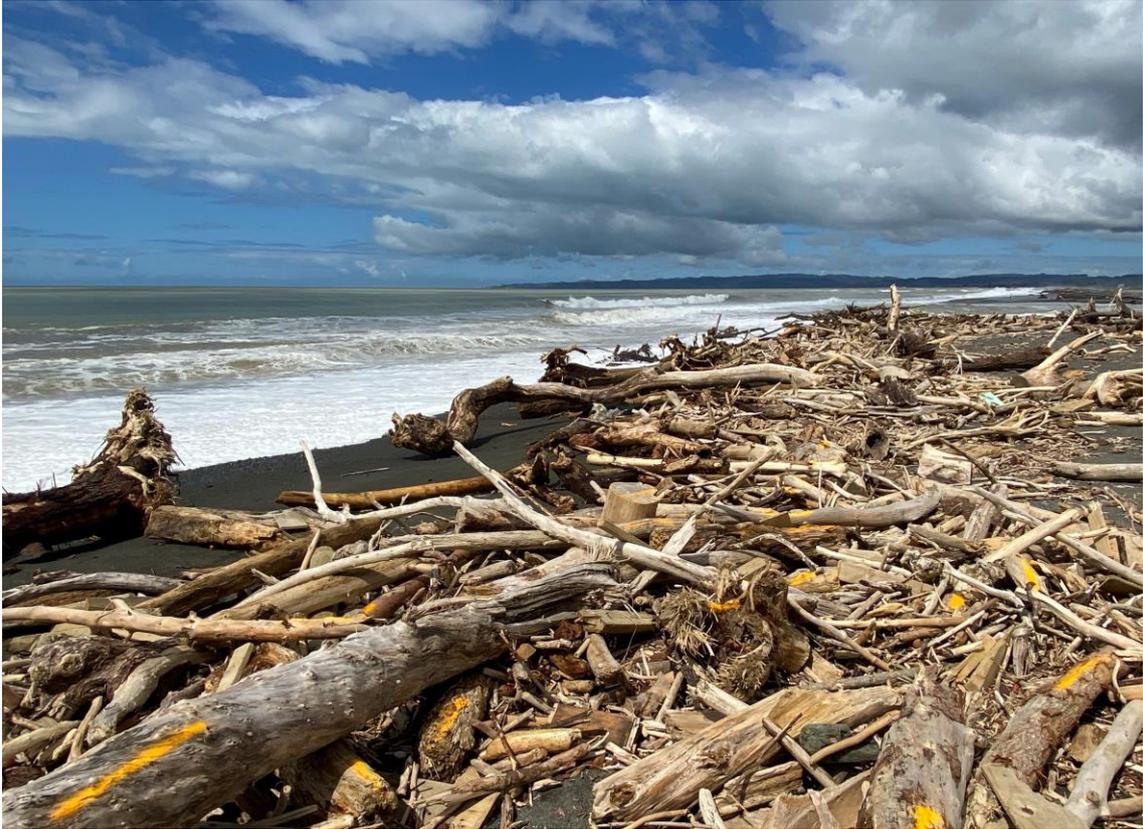
Figure 12: View south over the river mouth at Site 4 showing plot with dazzled wood.

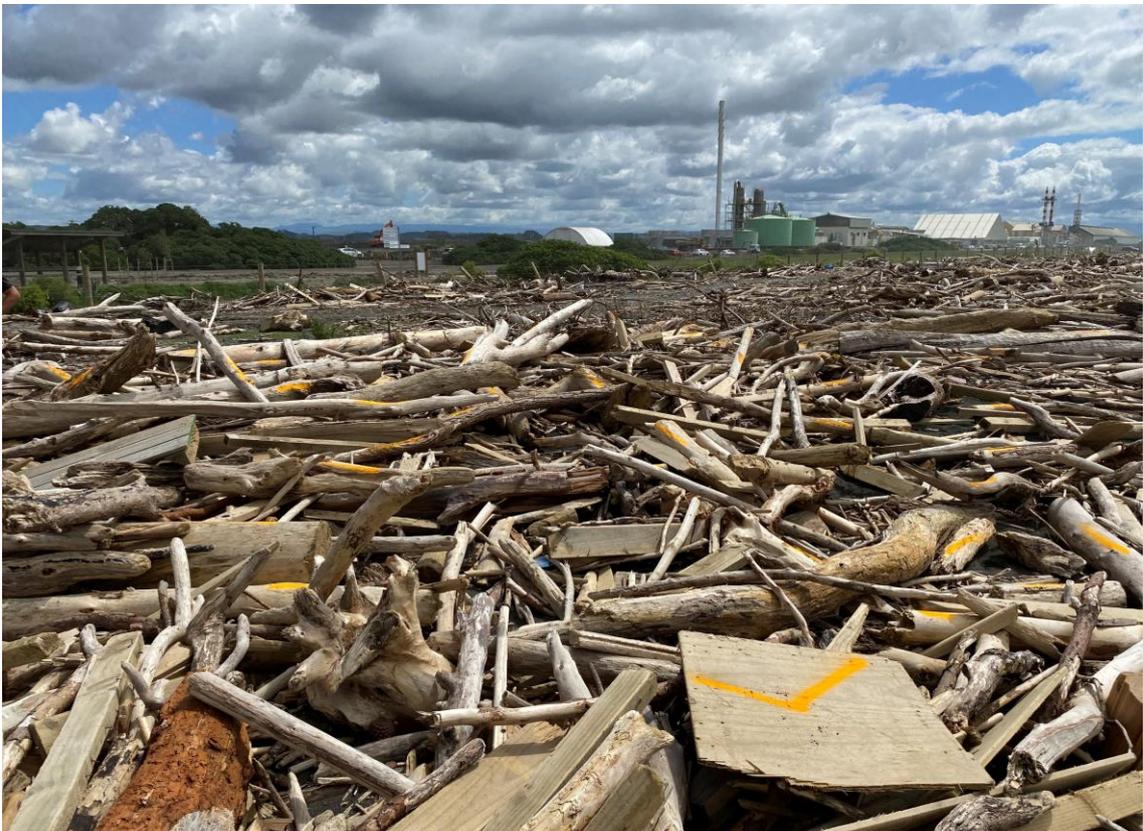
Figure 13: Typical woody debris accumulation assessed at Site 4.

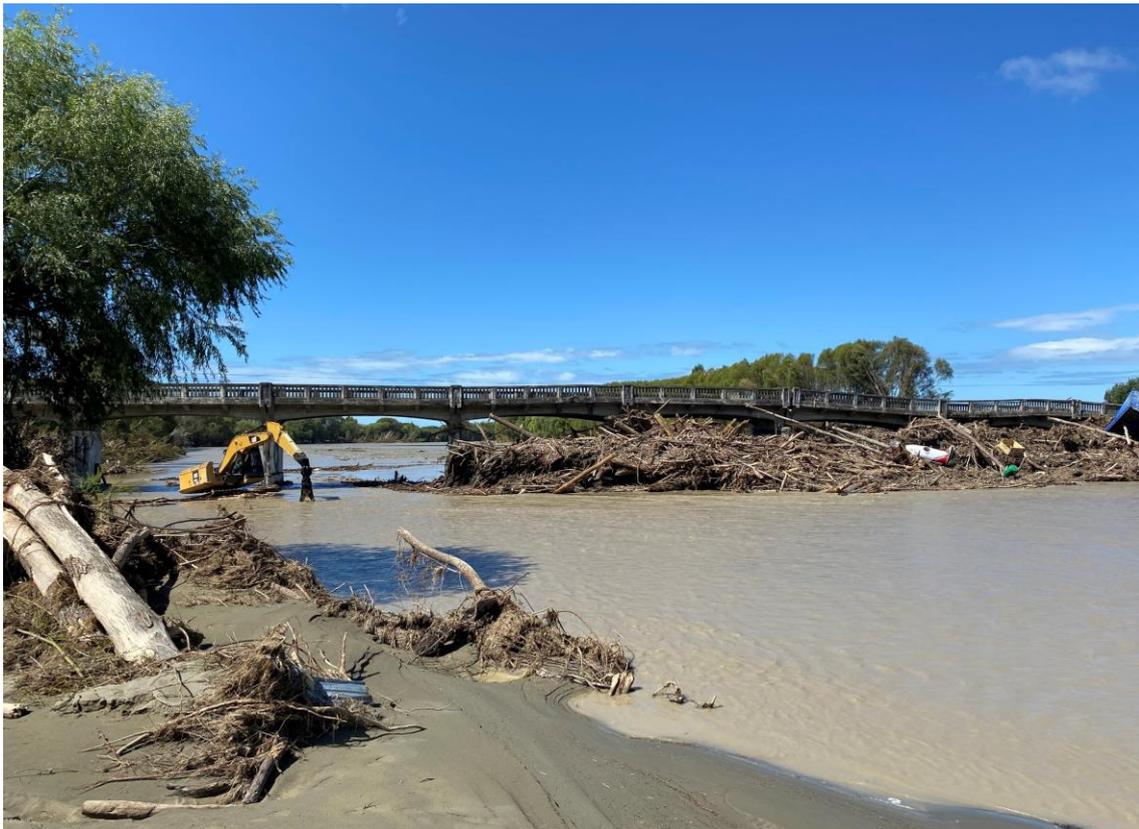
Figure 14: View from the true left bank over the destroyed Redclyffe Bridge at Site 5.

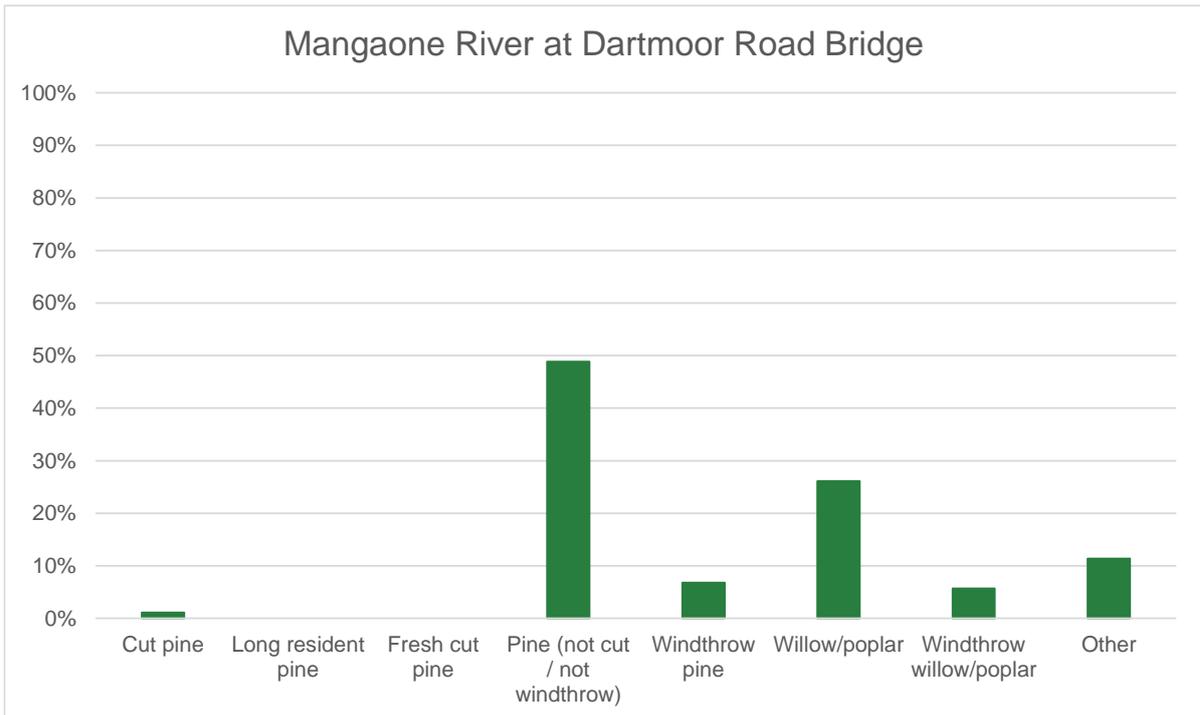
Figure 15: Within species breakdown of woody debris by piece type at Site 6.

The proportion of cut pine (whose source would be historic or current forestry harvesting operations) was 1% (Figure 15). The proportion of long resident pine debris was similarly low (0%). Interestingly the proportion of both windthrow pine (7%) and windthrow willow/poplar (6%) were similar and approximated the average of all sites assessed (M = 6% for windthrow pine, and M = 3% for windthrow willow/poplar).

The overwhelming majority of woody debris was however pine 'pieces' (49%) which constitute pieces of woody debris not evidencing cut (or other) marks indicating conclusively that they had been harvested (although that source of origin also cannot be completely ruled out). Willow/poplar was the next most frequently observed LWD contributing approximately half the number of pieces as pine 'pieces' (26%).

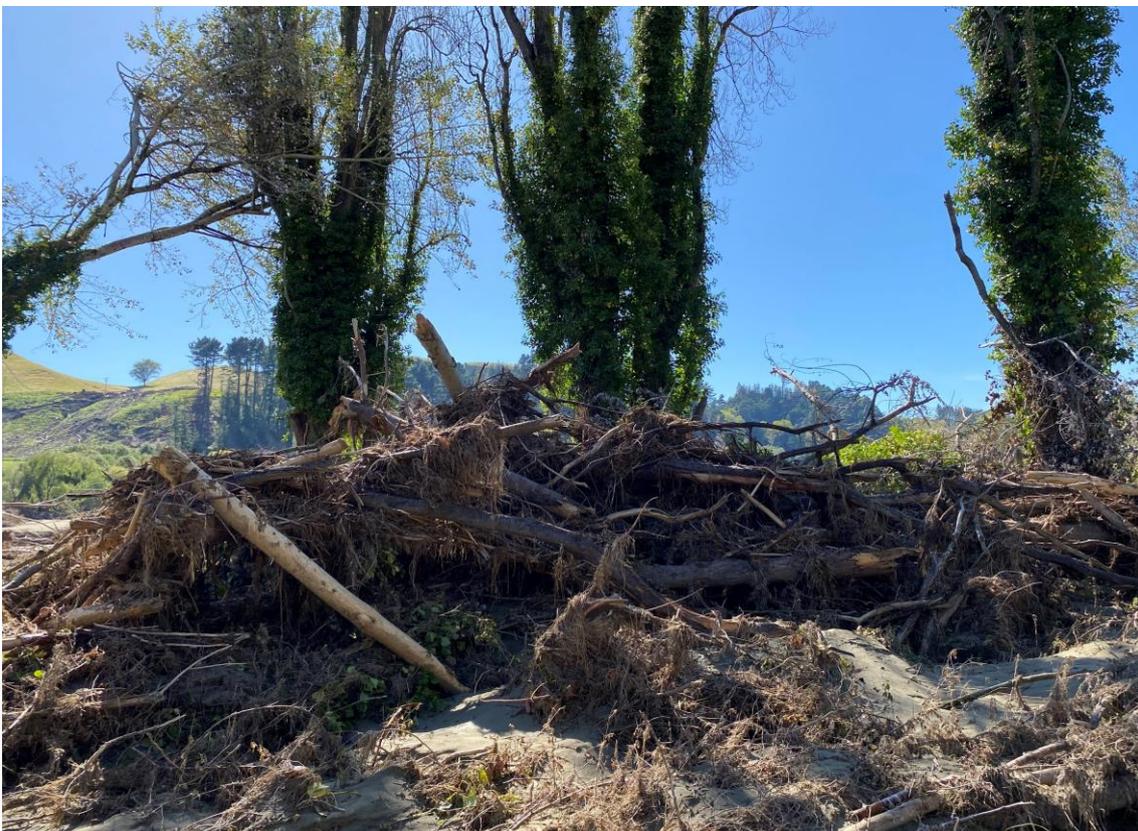
Figure 17: Typical woody debris accumulation assessed at Site 6.

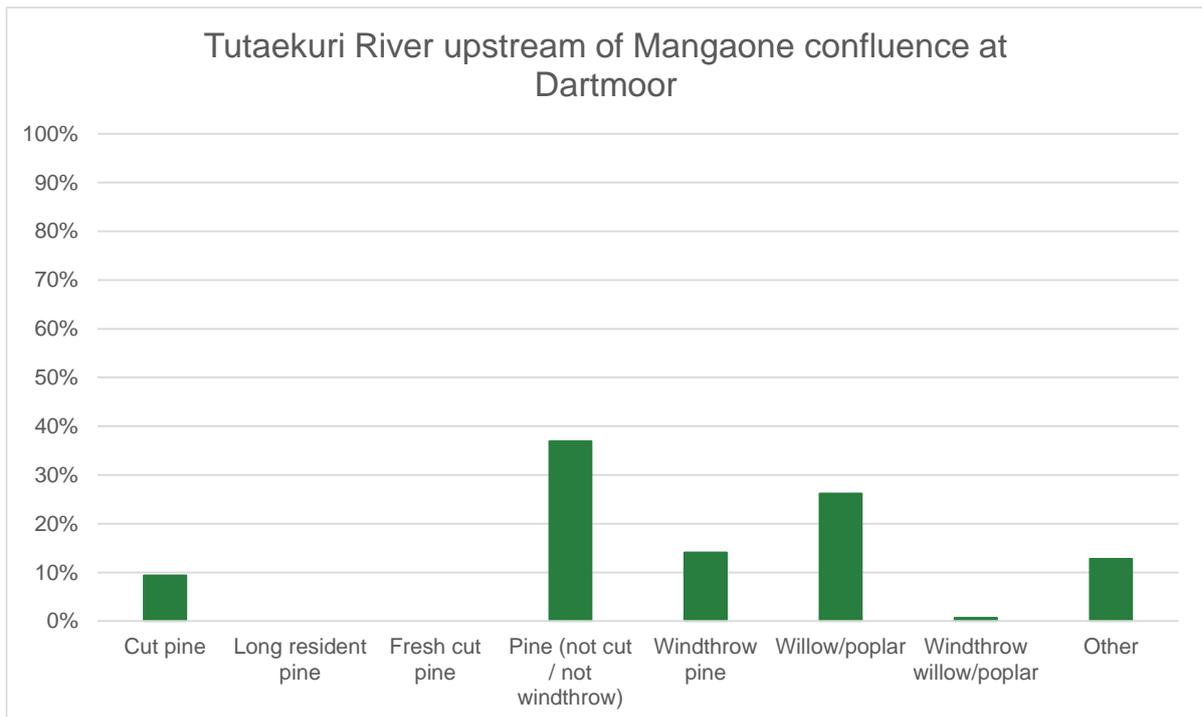
Figure 18: Within species breakdown of woody debris by piece type at Site 7.

The proportion of cut pine (whose source would be historic or current forestry harvesting operations) was 9% - the highest proportion recorded at any site assessed (Figure 18). This represents 8% more cut pine pieces than was observed at Site 6 (very close nearby but in a different river system) where only 1% of LWD was categorised as cut pine. The proportion of long resident pine was low (0%), suggesting that the cut pine LWD present had entered the river system recently (potentially and perhaps most likely during cyclone Gabrielle).

The majority of woody debris was however pine 'pieces' (37%) which constitute pieces of woody debris not evidencing cut (or other) marks indicating that they had been harvested. This value also represents the average value for pine 'pieces' across all sites assessed by either the *wood pile – hand count* or *square plot* method (N = 11, M = 37%, SD = 14%). Willow/poplar was the next most frequently observed LWD contributing 26% of LWD pieces.

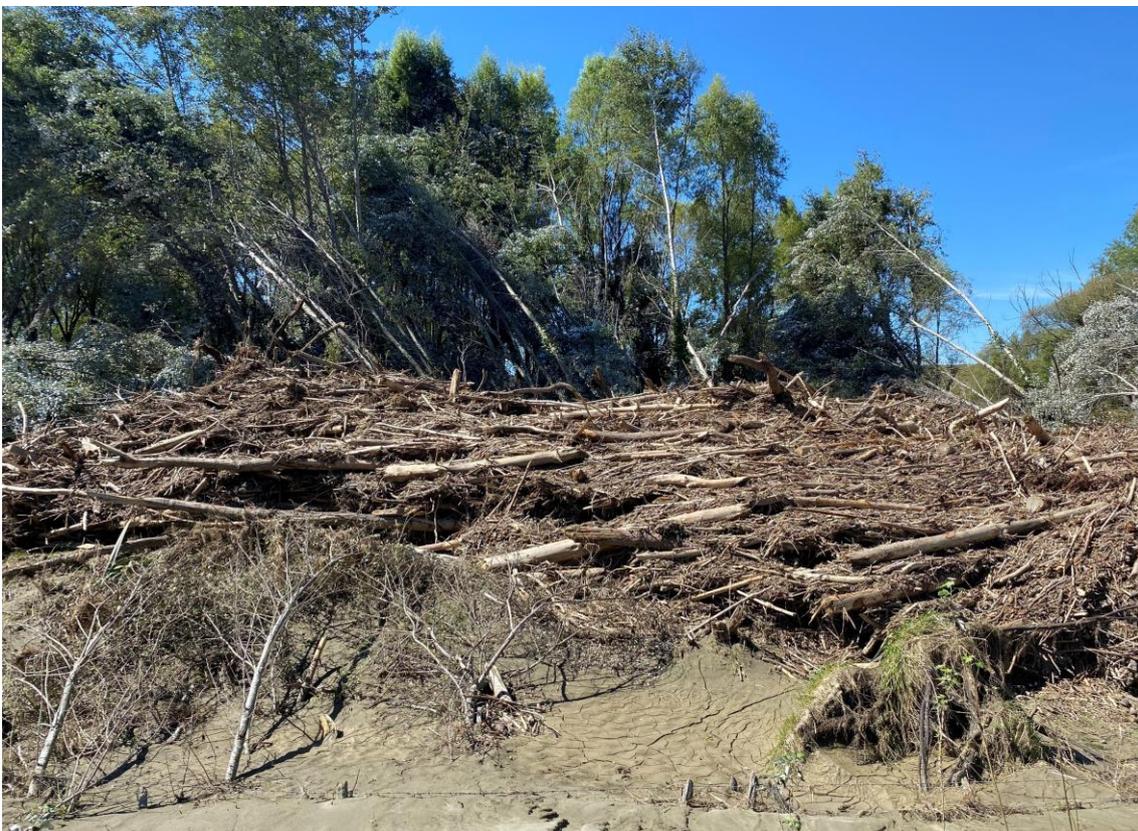
Figure 20: Typical woody debris accumulation assessed at Site 7.

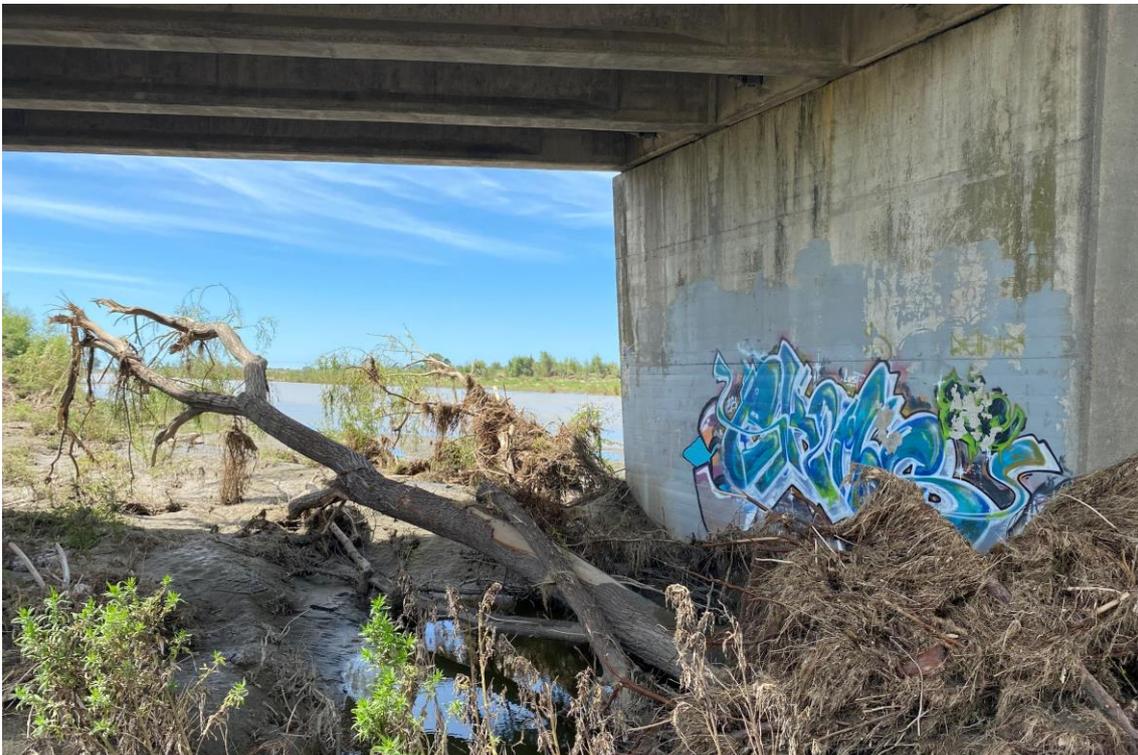
Figure 22: A windthrown willow was one of the few pieces of LWD seen at Site 8.

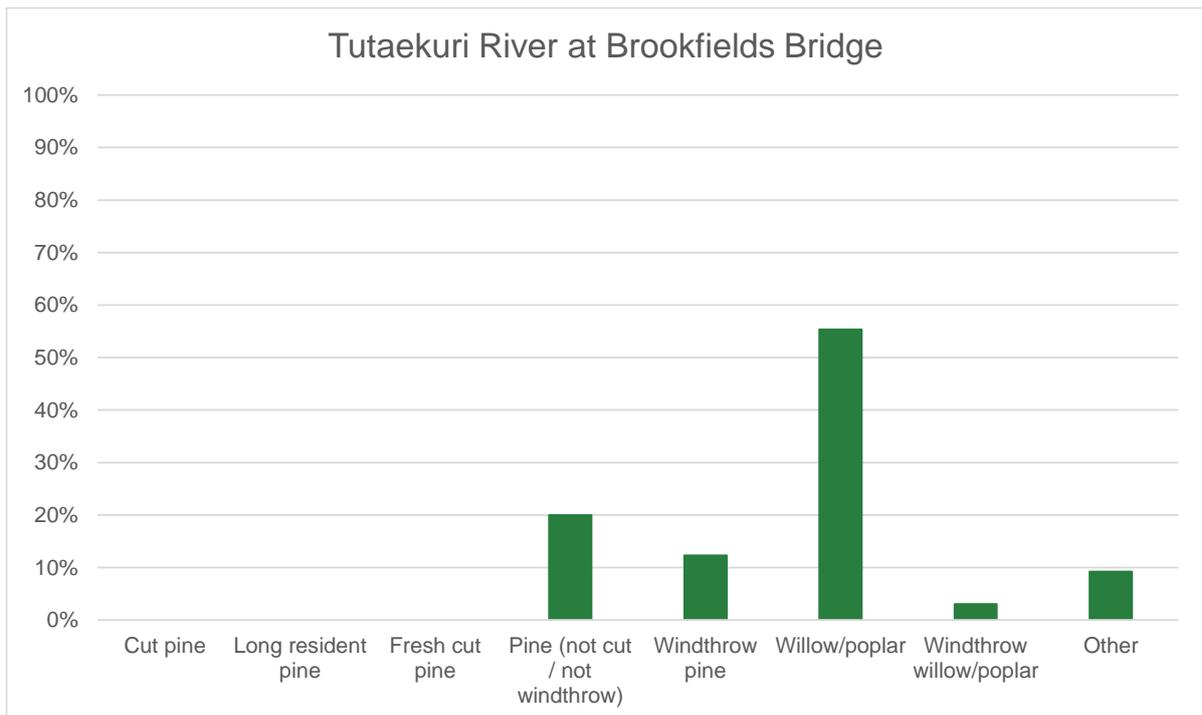
Figure 23: Within species breakdown of woody debris by piece type at Site 9.

The proportion of cut pine (whose source would be historic or current forestry harvesting operations) was 0% (Figure 23). The proportion of long resident pine debris was similarly low (0%). The proportion of windthrow pine (12%) was higher than the average of all sites assessed calculated in Section 3.18 (N = 11, M = 6%, SD = 5%) while windthrow willow/poplar (3%) was average (N = 11, M = 3%, SD = 5%).

The overwhelming majority of woody debris was willow/poplar (55%) with pine 'pieces' being the next most frequently observed LWD but contributing approximately one third the number of pieces (20%) as willow/poplar.

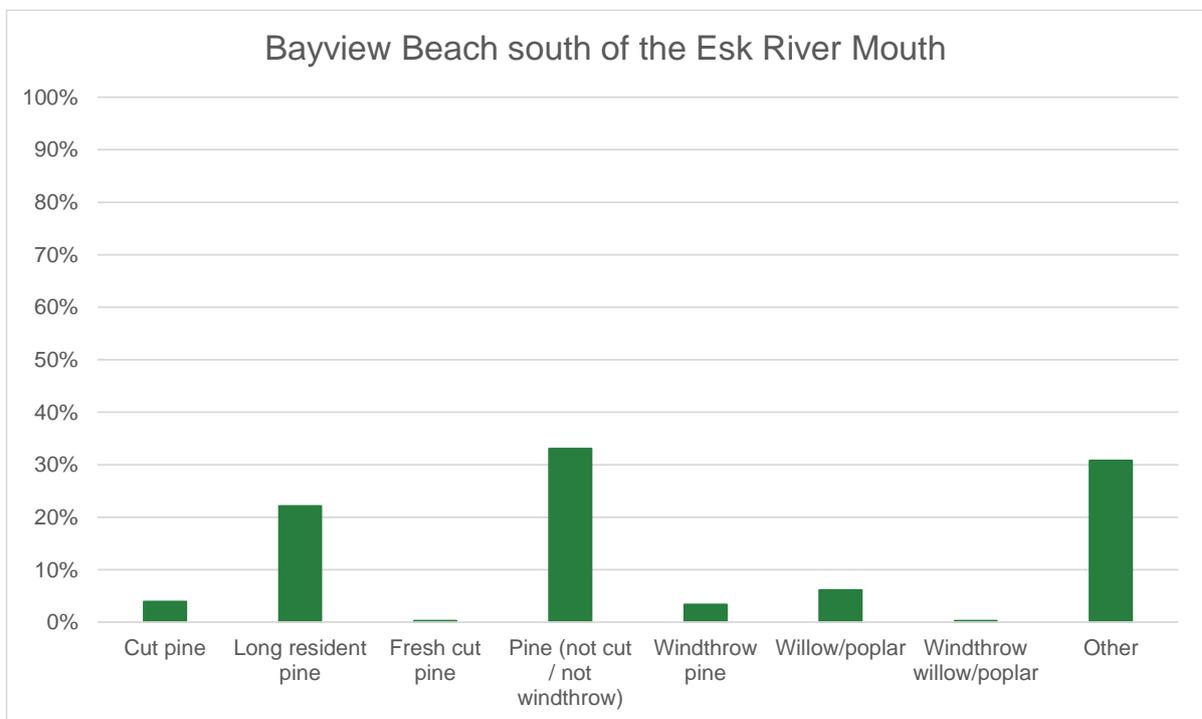
Figure 26: Within species breakdown of woody debris by piece type at Site 10.

The proportion of cut pine (whose source would be historic or current forestry harvesting operations) was 4% (Figure 26). The proportion of long resident pine debris was the highest of any site assessed at 22% (N = 11, M = 7%, SD = 9%). Interestingly the proportion of both windthrow pine (3%) and windthrow willow/poplar (0%) were both relatively low at this location.

The majority of woody debris was pine 'pieces' (33%), but in this instance not too dissimilar from either other species (31%) or long resident pine (22%). The presence of a large proportion of long resident pine may suggest that LWD within the Esk River catchment is not solely the result of Cyclone Gabrielle. However, long resident pine did not feature as prominently at Site 1 upstream where just 1% of LWD was assigned to this category.

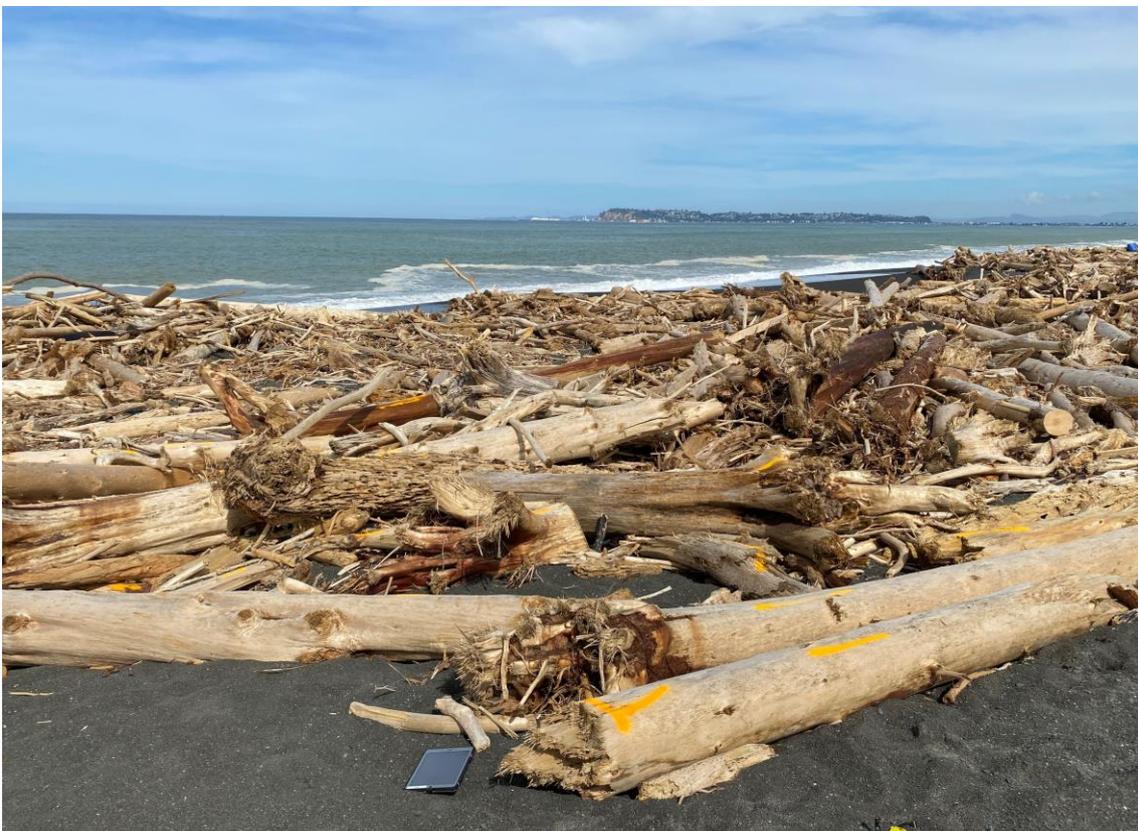
Figure 28: Typical woody debris accumulation assessed at Site 10 (view south).

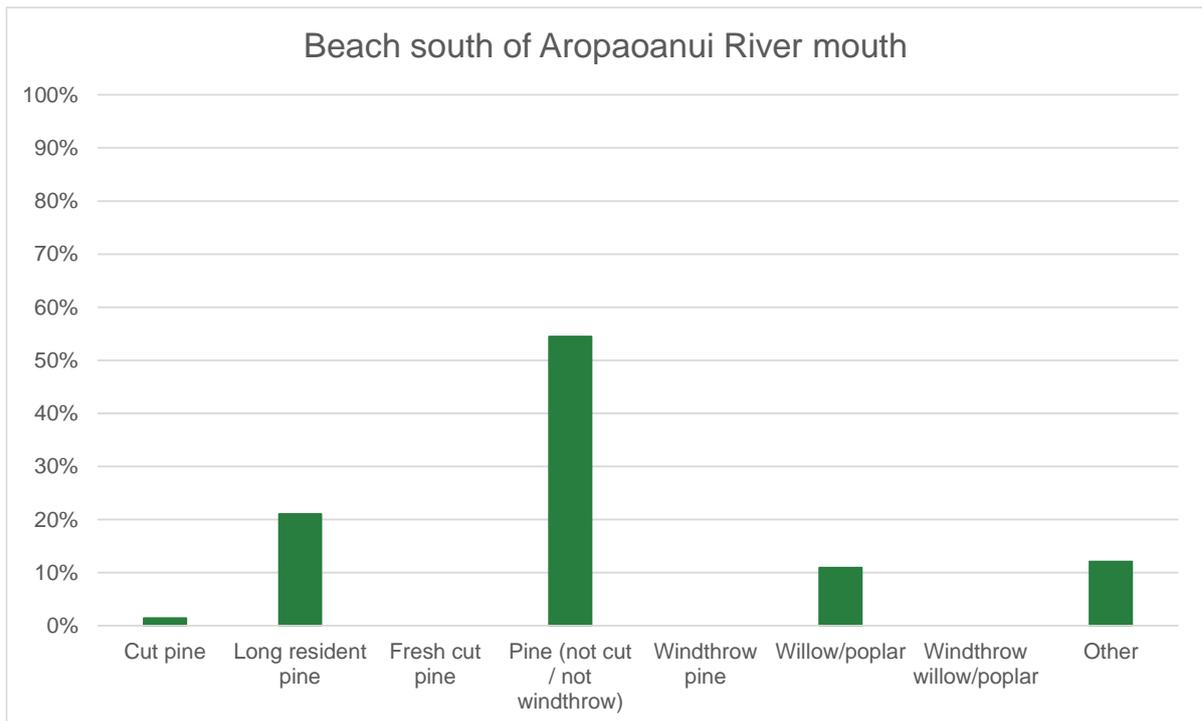
Figure 29: Within species breakdown of woody debris by piece type at Site 11.

The proportion of cut pine (whose source would be historic or current forestry harvesting operations) was 1% (Figure 29). The proportion of long resident pine debris was the second highest of any site (21%). The proportion of long resident pine LWD was lower than Site 10 to the south (22%) but higher than Site 12 to the north (15%). Interestingly the proportion of both windthrow pine (0%) and windthrow willow/poplar (0%) were the lowest of any site assessed. These proportions were similar only to Site 13 at Mahia Beach to the north where no windthrow material was recorded either.

The overwhelming majority of woody debris was however pine ‘pieces’ (33%) and long resident pine (21%). Many pieces categorised as long resident pine would have been categorised as pine ‘pieces’ if they had been of more recent origin (i.e., they too did not have any evidence of cut / processing marks associated with harvesting activity). Willow/poplar and other species were the next most frequently observed LWD categories contributing approximately only one third the number of LWD pieces counted as pine ‘pieces’ (11% and 12% respectively) and just half as much as long resident pine pieces counted.

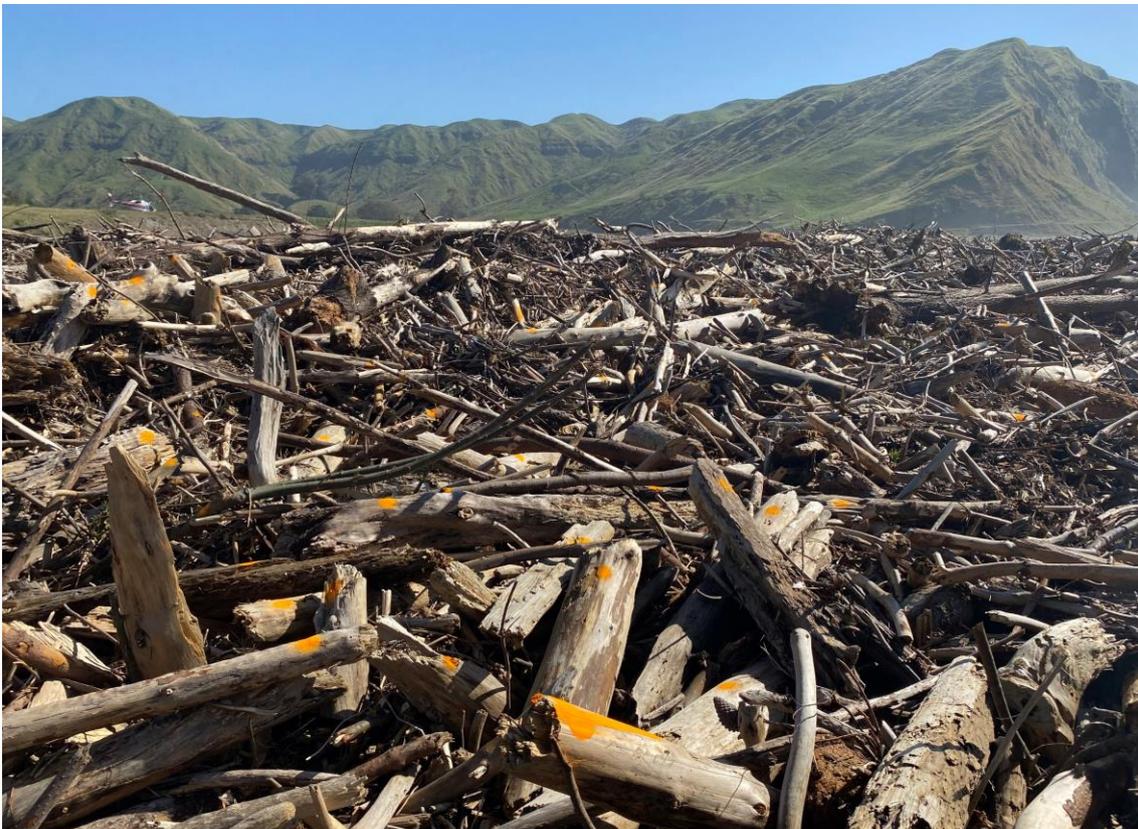
Figure 31: Typical woody debris accumulation assessed at Site 11.

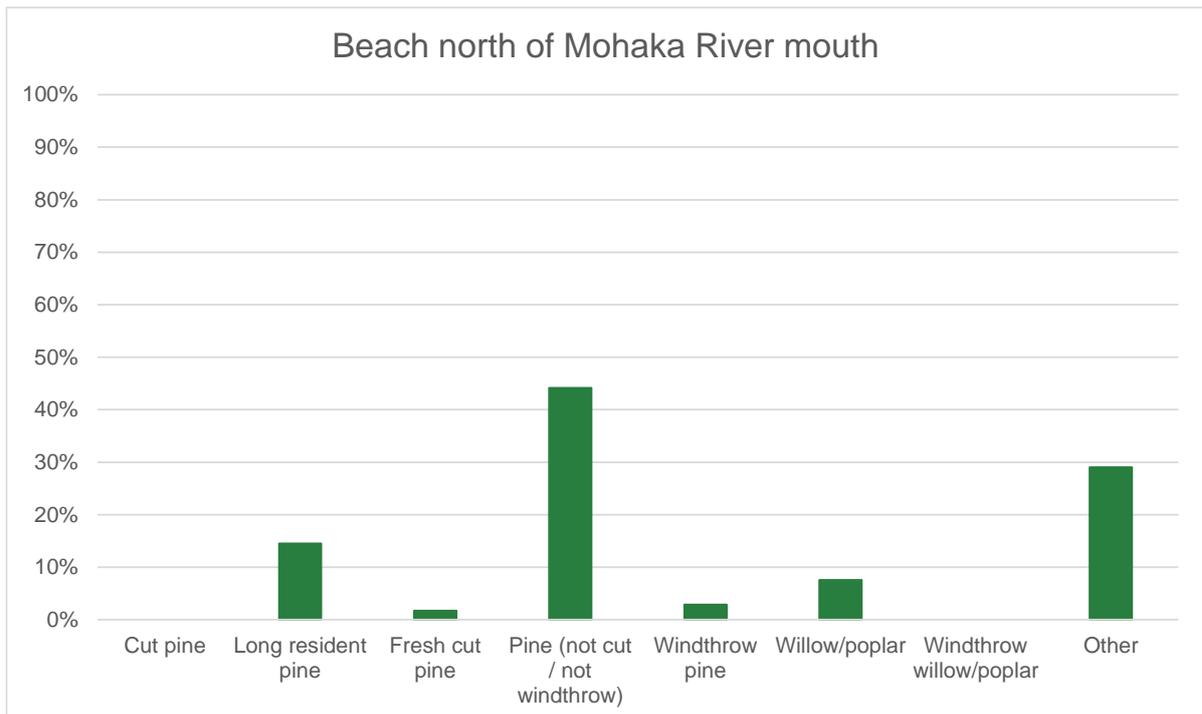
Figure 32: Within species breakdown of woody debris by piece type at Site 12.

The overwhelming majority of woody debris was pine ‘pieces’ (44%) which constitute pieces of woody debris not evidencing cut (or other) marks indicating that they had been harvested. Other species was the next most frequently observed LWD (26%) followed by long resident pine (15%).

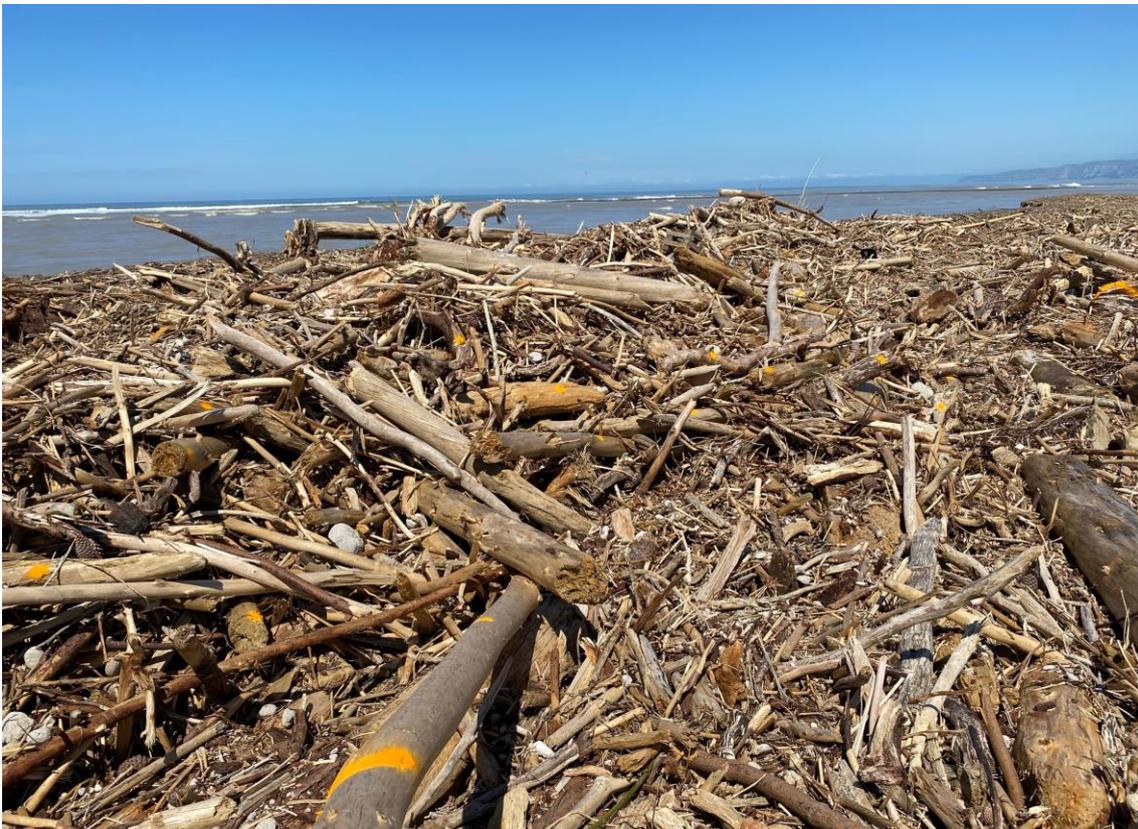
Figure 34: Typical woody debris accumulation assessed at Site 12.

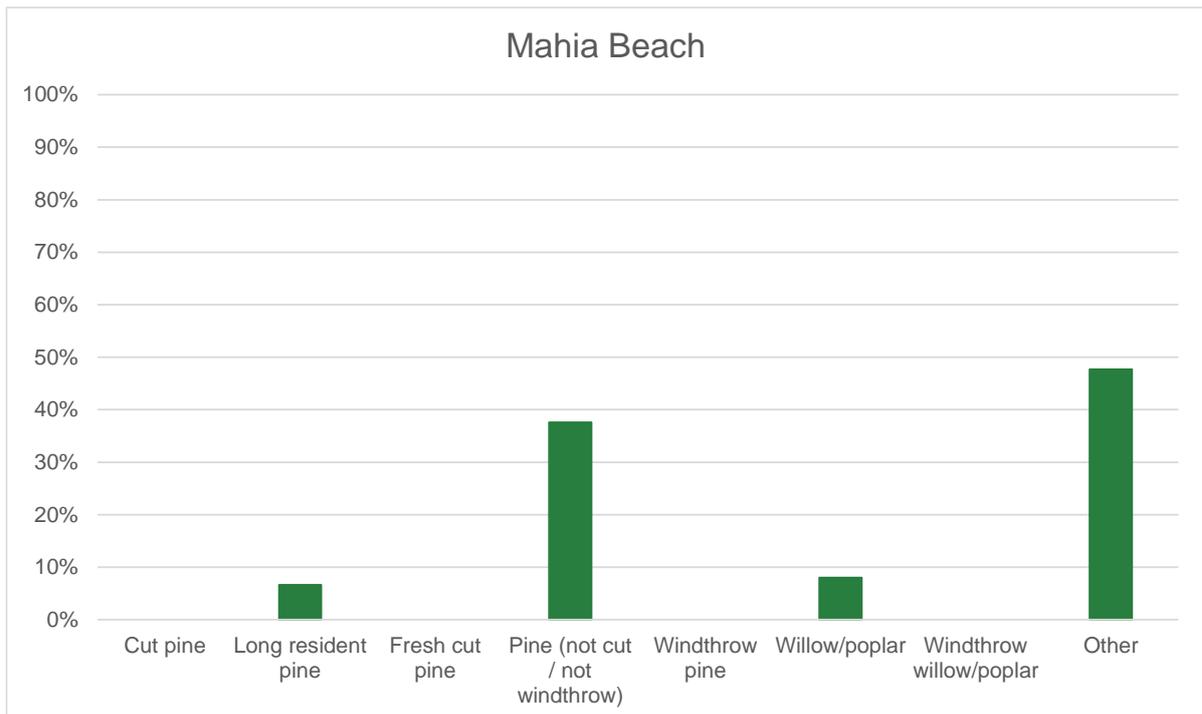
Figure 35: Within species breakdown of woody debris by piece type at Site 13.

The majority of woody debris was split fairly evenly between other species (48%) and pine 'pieces' (38%) which constitute pieces of woody debris not evidencing cut (or other) marks indicating that they had been harvested. Willow/poplar contributed only 8% of LWD assessed. The high percentage of other species in the coastal environment at this site in part reflects the increase in (usually small) unidentifiable woody debris present (e.g., due to time in water / abrasion removing distinctive features necessary for a positive species identification) that most people would recognise as '*driftwood*'.
