March 2023

Cyclone Gabrielle Woody Debris Species Composition Assessment

Submitted to:
Hawke's Bay Regional Council

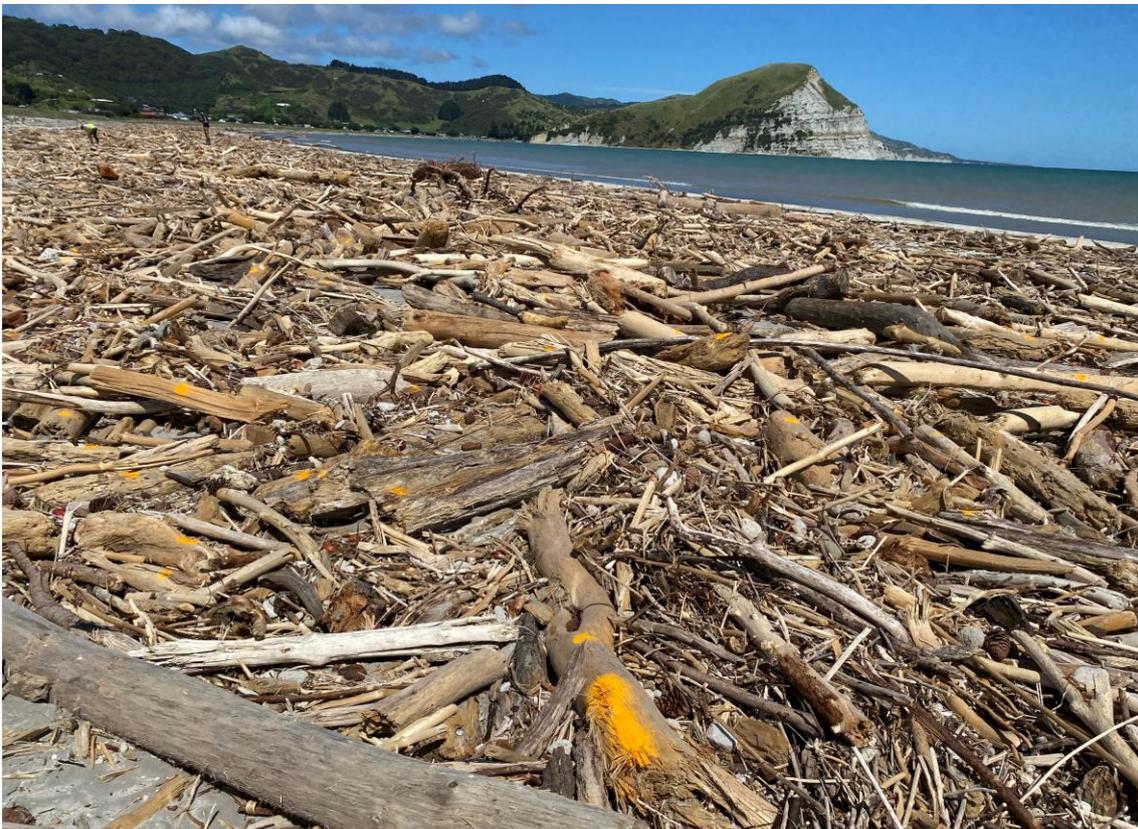
Figure 37: Typical woody debris accumulation assessed at Site 13.

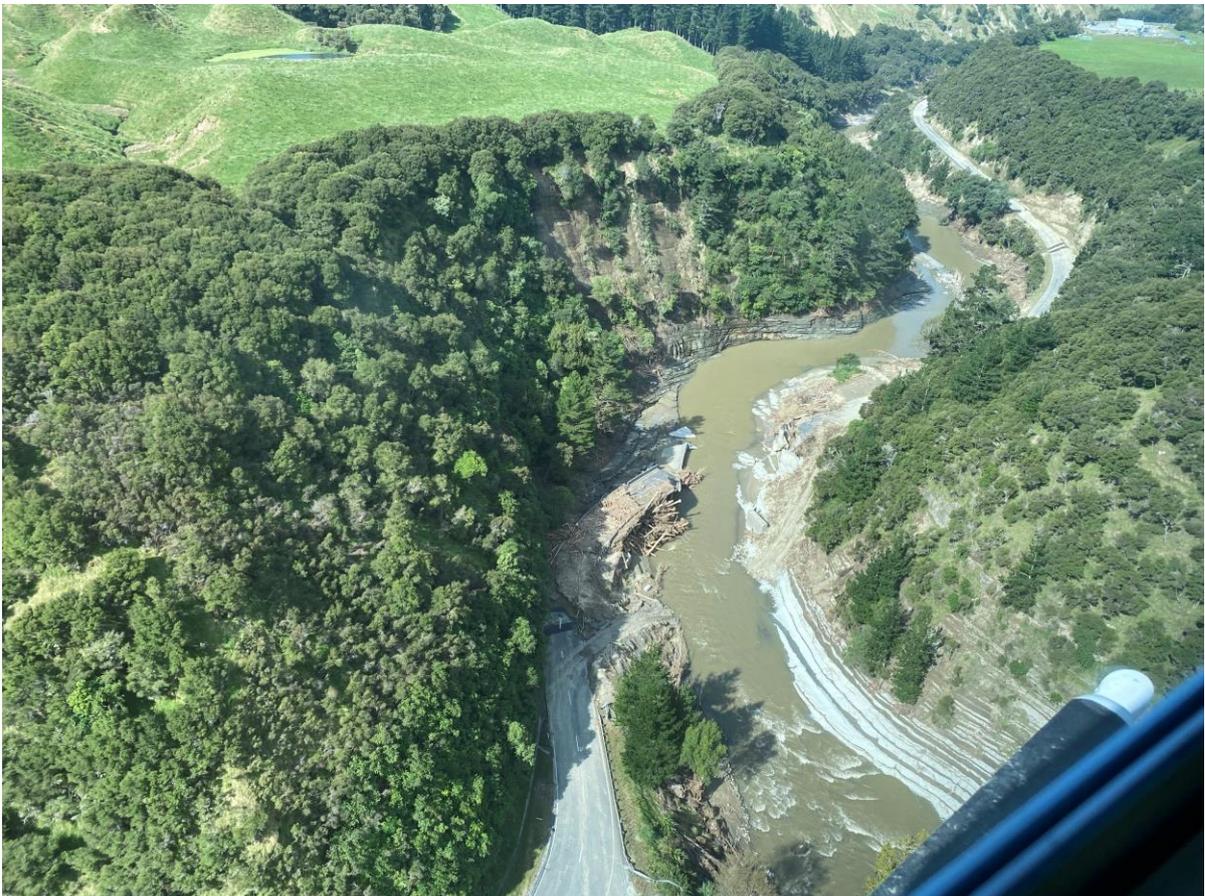
Figure 40: View of the destroyed SH2 road bridge on the Waikare River and Site 16.

It is recommended that this site is revisited and assessed quantitatively once access is safely obtainable. This may be best achieved using the *wood pile – deconstruction* methodology, assuming that the woody debris is able to be safely removed and stockpiled elsewhere. In addition, given the volume and type of material present (both there and at Site 17 downstream at the coast), further investigation as to potential material sources within the Waikare River catchment is recommended.

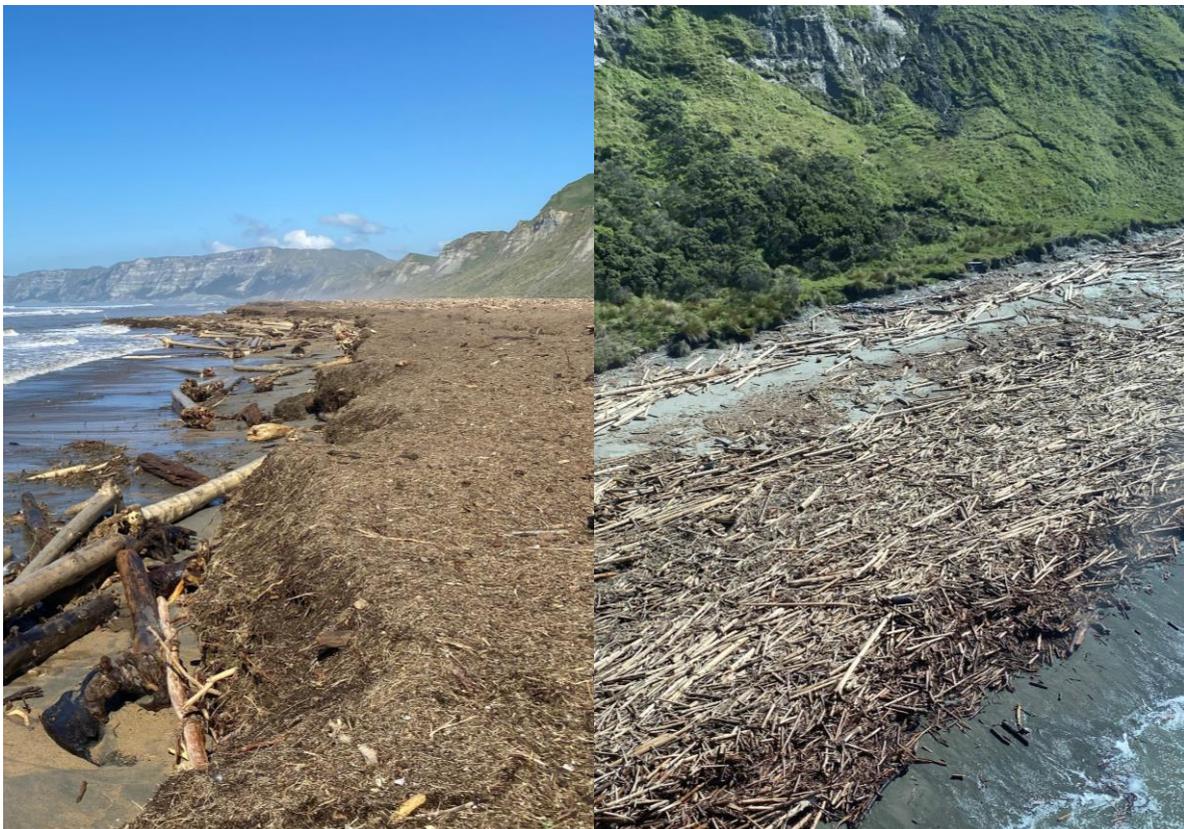
Figure 41: A deep layer of fine debris covered LWD accumulations at Site 17 (left) while to the south LWD of pine species origin appeared dominant (right).

It is recommended that this site is revisited and assessed quantitatively if tidal action removes the fine debris accumulation revealing LWD suitable for assessment, or an alternative safe landing location is found.

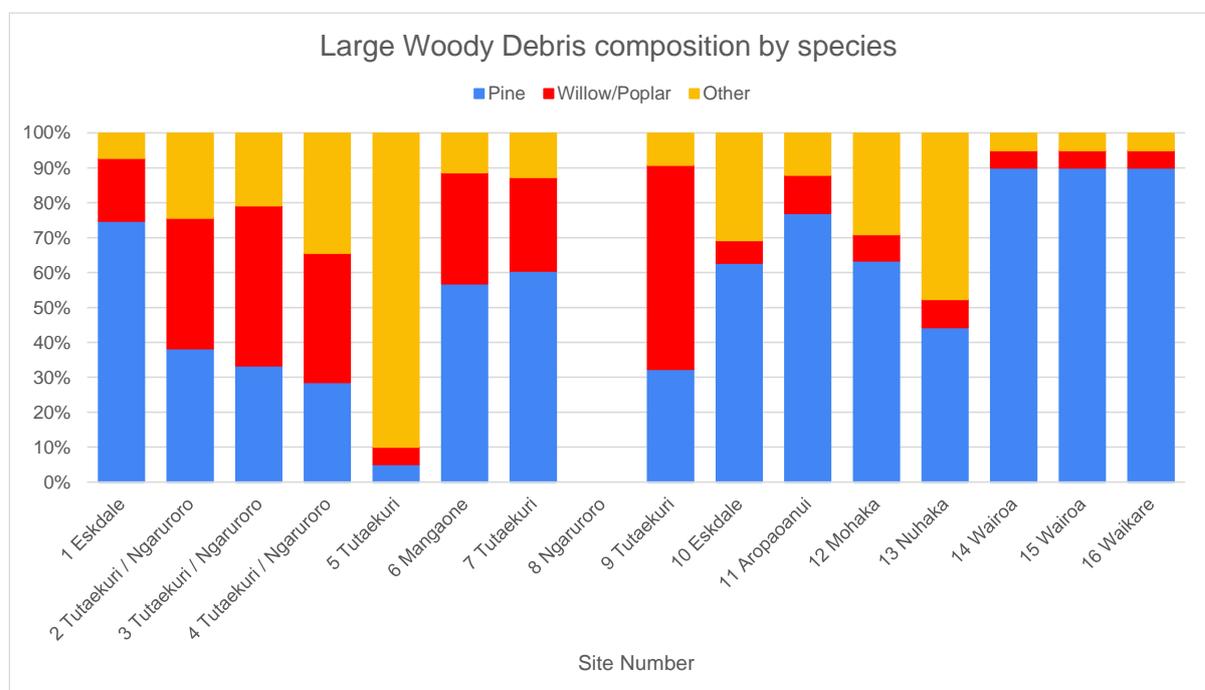
Figure 42: Large woody debris composition by species at all sites.

The proportion of pine, willow/poplar and other species in the woody debris accumulation at the bridge was visually assessed as comprising 90%, 5% and 5% respectively (Figure 42).

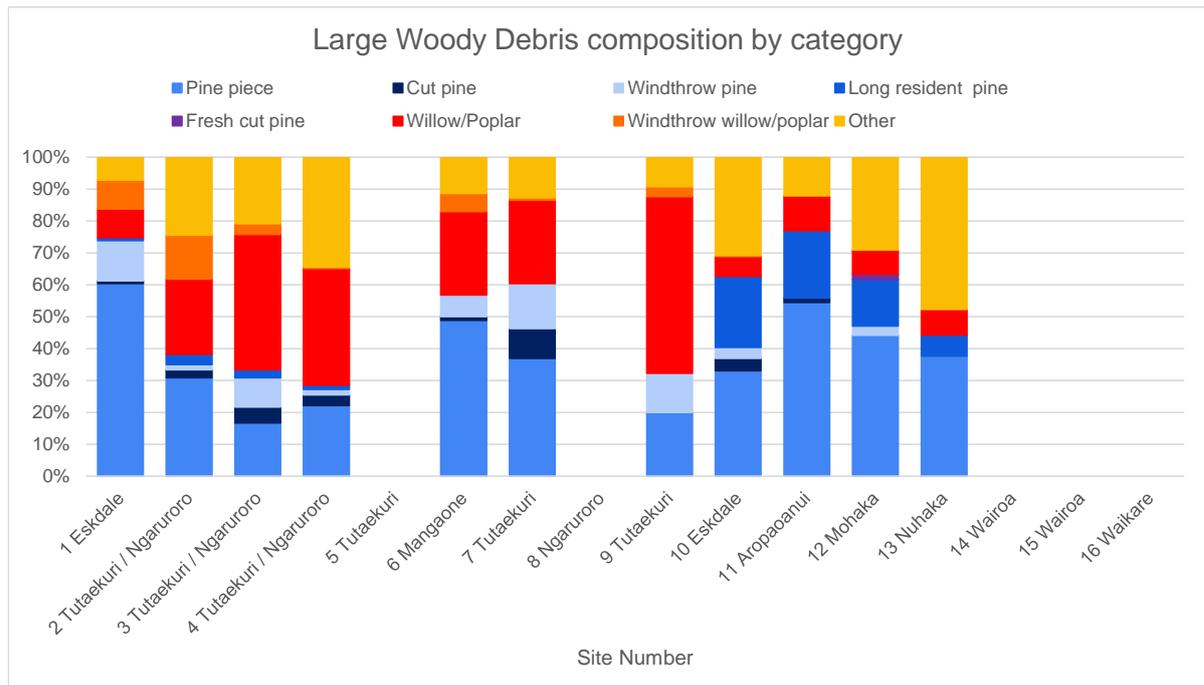
Figure 43: Large woody debris composition by category at all sites.

The average proportions of LWD assigned to each of the eight categories at the 11 sites for which qualitative data was collected were as follows (presented in the order they appear in Figure 43 from bottom to top): pine piece (M = 37%, SD = 14%), cut pine (M = 3%, SD = 3%), windthrow pine (M = 6%, SD = 5%), long resident pine (M = 7%, SD = 9%), fresh cut pine (M = 0%, SD = 1%), willow/poplar (M = 23%, SD = 16%), windthrow willow/poplar (M = 3%, SD = 5%), and other species (M = 22%, SD = 13%).

By far the most common category of pine species LWD recorded on average was *pine piece* (N = 11, M = 37%, SD = 14%, min = 17%, max = 60%). This LWD assessment category is defined as pieces of LWD not evidencing cut (or other) marks indicating that they have been harvested (either recently or historically). All other categories into which pine species LWD were placed averaged less than 10% across all 11 sites. Of particular note was the low contribution that *cut pine* made on average (N = 11, M = 3%, SD = 3%, min = 0%, max = 9%). It should be noted here that absence of cut (or other marks) is not absolute confirmation that LWD in this category has not originated from harvesting activity. Breakage is a common occurrence during tree felling, for example.

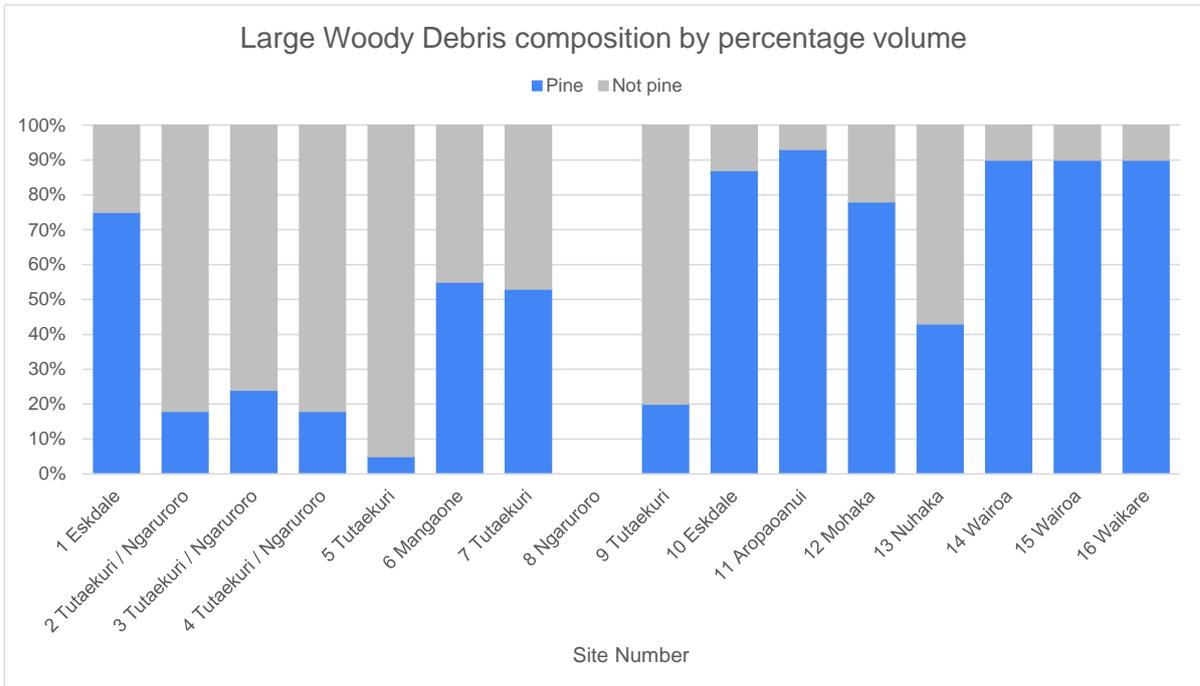
Figure 44: Large woody debris composition by percentage volume at all sites.

The average proportions of pine species LWD by volume across all sites assessed was 56% (N = 15, SD = 32%, min = 5%, max = 90%) (Figure 44).
